System Failure Case Studies

DECEMBER 2006

Volume 1 Issue 2

SUBMARINE DOWN

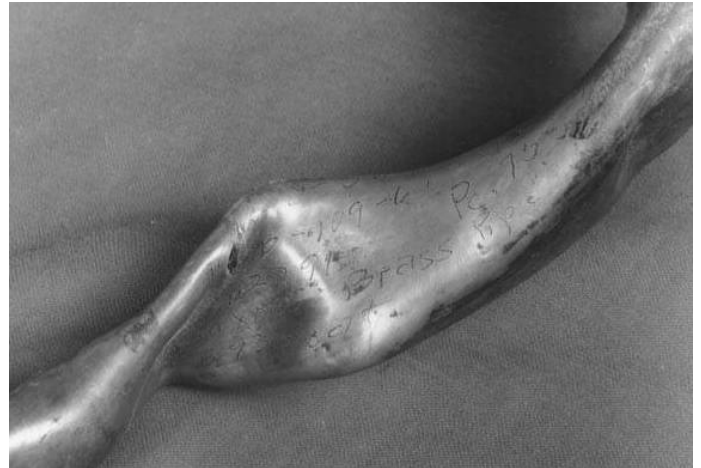
It remains uncertain what was happening at this time, but the best theory, based on the Naval investigation report, is that some pipes had started to leak in the submarine’s engine room. These leaks allowed electrically conductive seawater to get into the electronics that controlled the nuclear reactor, which in turn shorted out and shut the reactor down.

A section of brass sea water piping recovered from the USS Thresher.

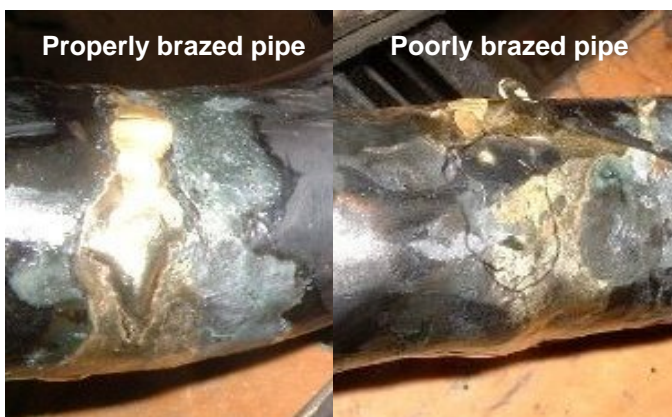
According to published reports, there were perhaps several factors that came together to destroy the USS THRESHER and its crew. The leak itself probably occurred because of faulty brazing of the piping at the shipyard. Prior to the USS THRESHER loss, the installation procedure for pipes less than four inches in diameter was to put a silver ring at the joint between two points and braze it with a torch.

Poorly brazed pipes led to the electrical shortage that led to the loss of the USS THRESHER.

Subsequent investigation of other ships after the accident showed that, though joints created in this manner appeared solid, when broken apart there was no silver in them, indicating that they were much weaker than had been previously estimated. In general, the design and

As a result of the loss of the USS THRESHER, a major new initiative was undertaken by the Navy, called "SUBSAFE," to reform design and manufacturing processes (similar in many ways to changes at NASA following the Apollo 1, Challenger and Columbia disasters). Part of this initiative was to end the practice of brazing smaller pipes, and to instead start welding and doing x-ray inspection of joints to verify their integrity. It also resulted in changes in designs of the system that blows out the ballast tanks, providing a capability to do so seven times faster than the system used in the USS THRESHER.

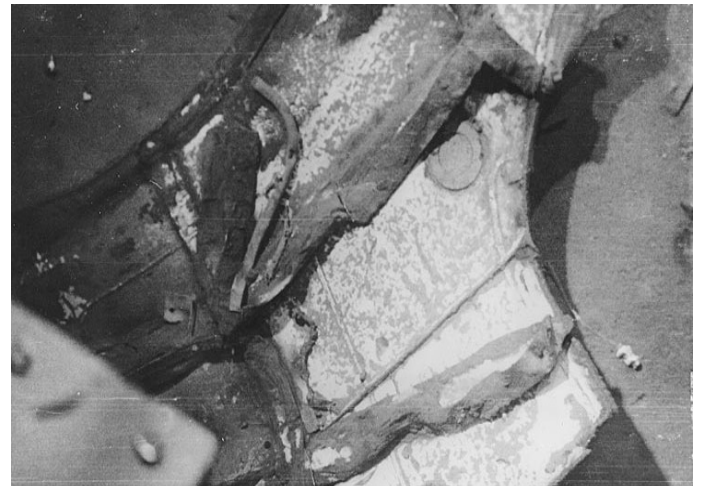
From this point on, the only sounds picked up by the open microphone were the distinctive and dismaying creaks of straining metal and fasteners as the craft sank deeper and started to crush under the unimaginable external pressure. The submarine eventually broke into several pieces, killing almost instantly all 129 crew and observers aboard. It continued to sink, falling almost two miles to the floor of the Atlantic, prematurely ending the career of the most advanced submarine built to that date.

Wreckage from the USS THRESHER's sonar dome can be seen on the ocean floor.
